# Roof System Inspection Report

1234 Somewhere Dr.  
Yourtown, MI 48888

RoofAdvisor LLC  
20:59 August 15, 2016

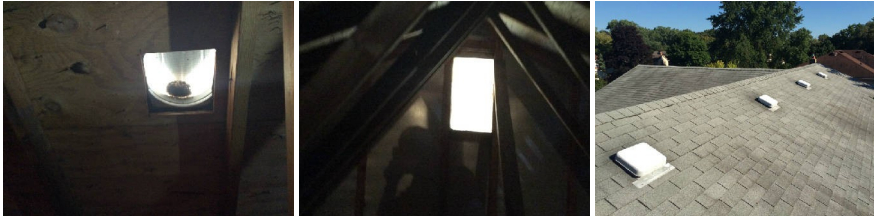
8. Watch Ventilation Exhaust: Gable Vents Box Vents **Insufficient Ventilation for Size of Structure. 1/300 Rule**

2. House Attic Ventilation Exhaust: Gable Vents Box Vents Insufficient Ventilation for Size of Structure. 1/300 Rule

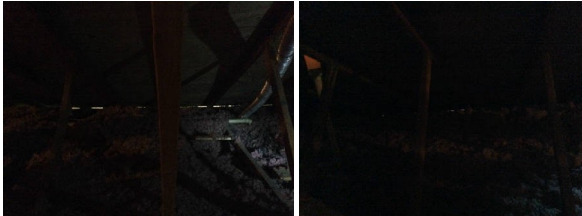
9. Defective Ventilation Intake: NONE **Insufficient Ventilation for Size of Structure. 1/300 Rule.**

2. House Attic Ventilation Intake: NONE Insufficient Ventilation for Size of Structure. 1/300 Rule.

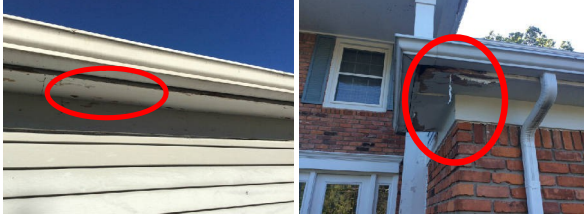
- 1. Acceptable     Gutters: Sectional
- 2. Defective     Eaves: Eaves Damaged - deteriorating

5. Main Property Exterior Surface Eaves: Eaves Damaged - deteriorating

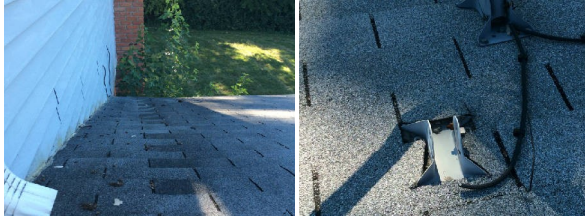
- 1. Method of Inspection: On roof
- 2. Approximate Age: 11-15 years
- 3. Unable to Inspect: 0%
- 4. Number of Layers 1
- 5. Material: Asphalt shingle - Roof shows signs of deterioration

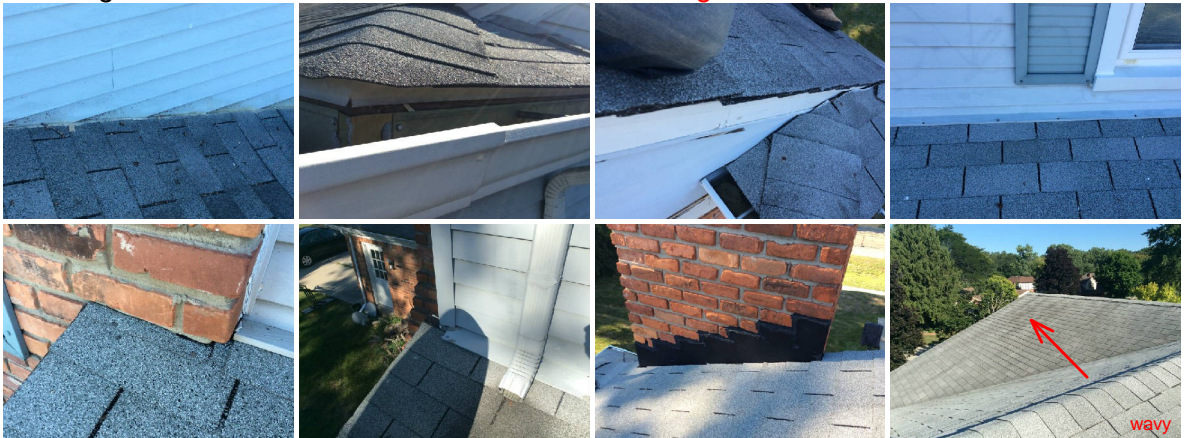
- 6. Defective     Flashing: Aluminum - Sealant used instead of flashing

6. Flashing: Aluminum - Sealant used instead of flashing

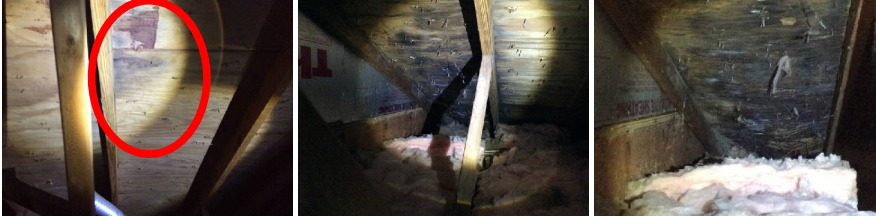
1. House Attic Sheathing: Solid Plywood - Water damage present

5. Defective Sheathing: Solid Plywood - Water damage present
