PROJECT SUMMARY

KROGER #539

KILGORE COLLEGE PORTER BUSINESS BUILDING FOUNDATION LEVELING

RUSTON FURNANCE ST. GOBIAN CONTAINERS

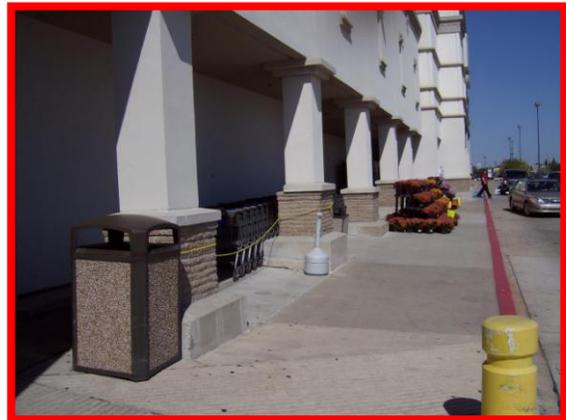
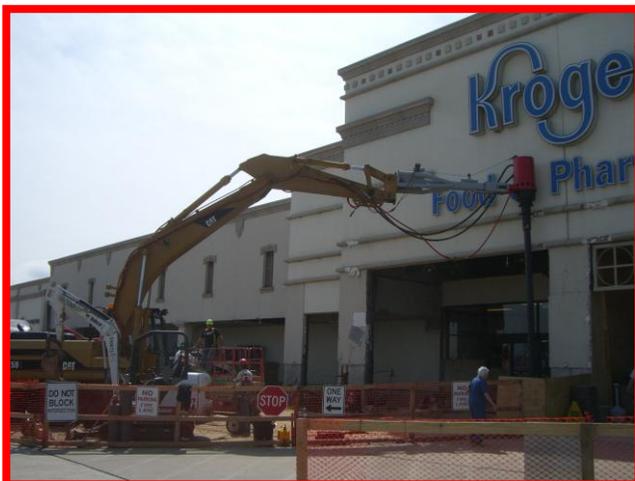
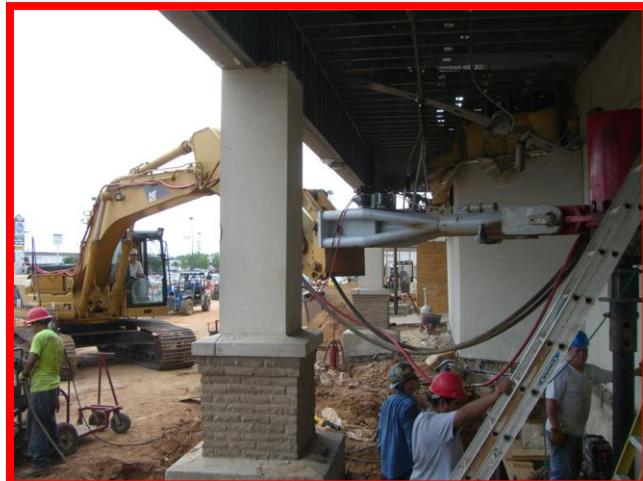
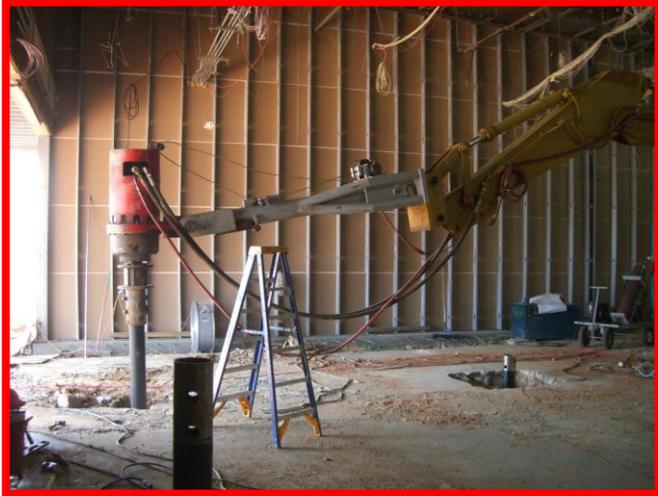
KROGER #539

Design Details: Driven piles were excluded from repair options due to the 12' overhang, which would require removal of large portions of the roof, and substantial noise disturbance to neighboring stores, not to mention extended closure of the store. The EOR specified piles with 300 kip ultimate capacity providing a 2.0.1 factor of safety. Power Lift installed (118) 7" O.D. Helical Piles with 24"

helical plates 1" thick to depths of 60' to 80'.

The piles were installed using specially designed attachments for Power Lift's equipment allowing piles to be installed with as little as 12' of headroom. In low overhead clearance areas the

piles were installed in 10' sections. A specialized process weld was developed to provide full penetration welds in approximately 10 minutes per connection. Each pile was installed to a minimum installation torque of more than 80,000 ft/lbs. to insure the 300 kip ultimate capacity was achieved. After all piles were installed, the structure was raised more than 8" using Power Lift's proprietary lifting equipment and is now permanently supported on Power Lift Piles.

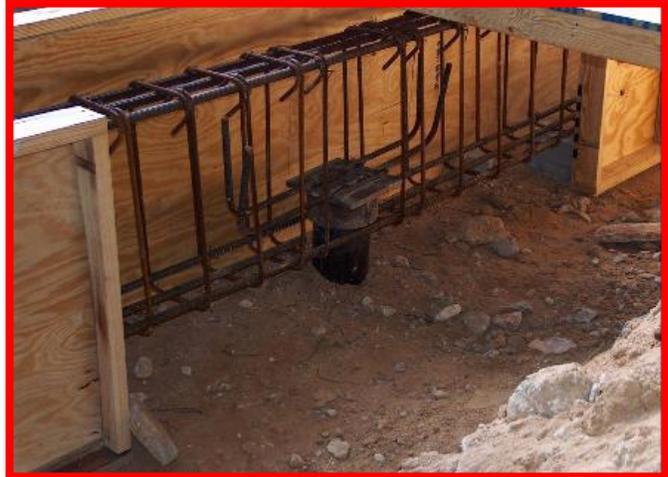
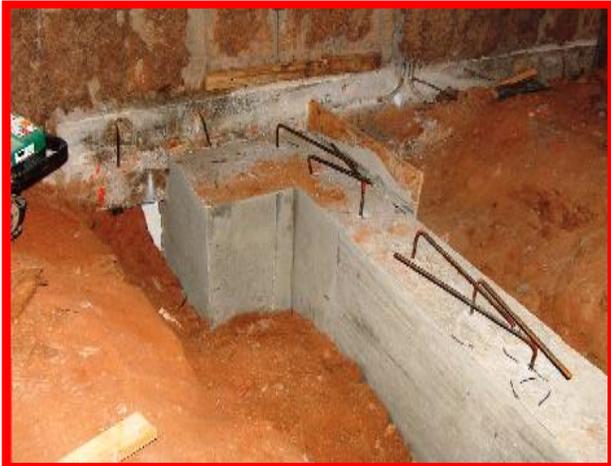
The project consisted of providing piles to support and raise the existing tilt wall structure and support approximately 16,000 sq ft of new 8" thick suspended concrete floor. All work was completed

while the store remained fully functional, closing only small areas at a time.

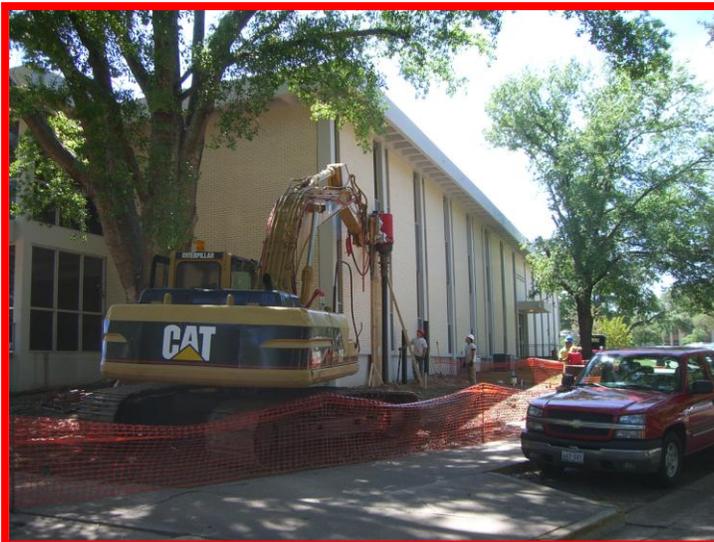
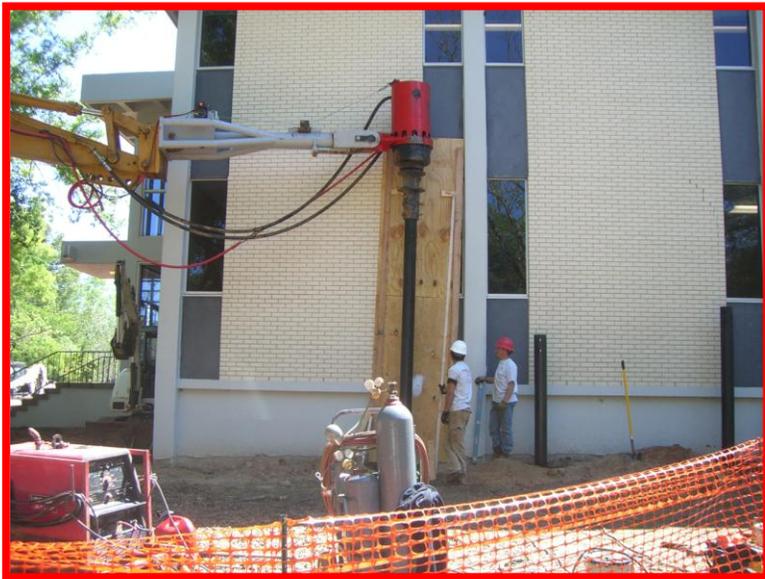
KILGORE COLLEGE – PORTER BUSINESS BLDG.

Subsurface Conditions: Expansive clays were present to a depth of 30'. The soil borings reflected desiccated soils in the upper 10' to 15', likely associated with large trees located close to the structure. A clayey shale formation was located at a depth of 20' and beyond. The Engineer of Record determined that support elements bearing in the shale would be suitable for underpinning the structure. However, the contractor was charged for the complete design of the underpinning system.

Design Details: Power Lift worked with Smith Engineering, Inc., in designing a large capacity helical pile underpinning system for the project. 8-5/8" O.D. pile with ultimate capacities ranging to 300 kips were designed. The piles were equipped with multiple 3/4" thick helical flights and were founded at depths of $\pm 25'$. The foundation support brackets were equipped with sleeves to stiffen the piles in the high moment area due to the eccentric load. Once all piles were installed, foundation load was transferred

to the new helical piles. The original concrete drilled shafts were severed from the grade beam and Power Lift's synchronized lifting system was utilized to raise the foundation to the correct elevation. Once raised, the piles were welded to the foundation support brackets and permanently supported on Power Lift's power torqued helical steel piles.

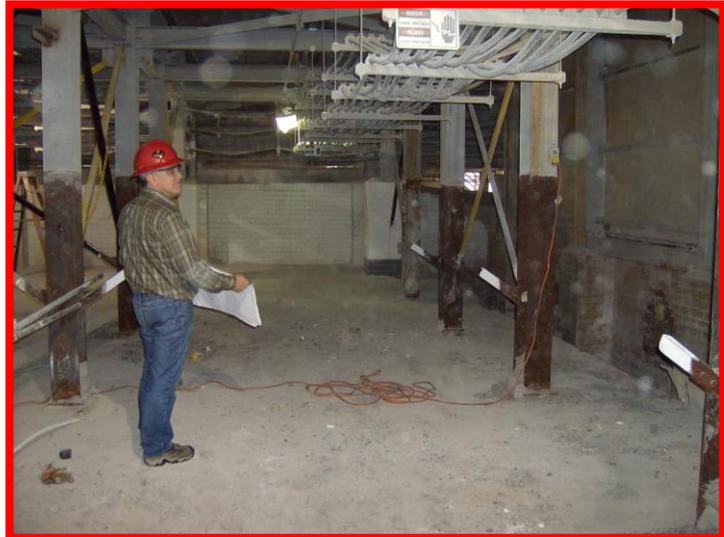
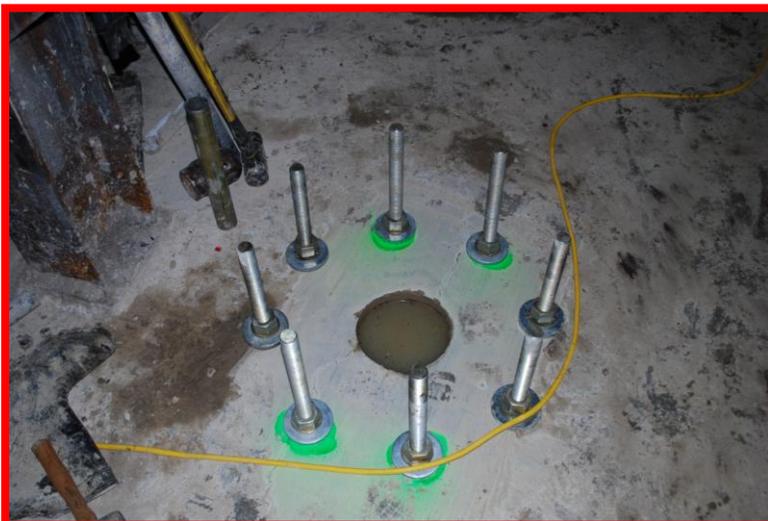
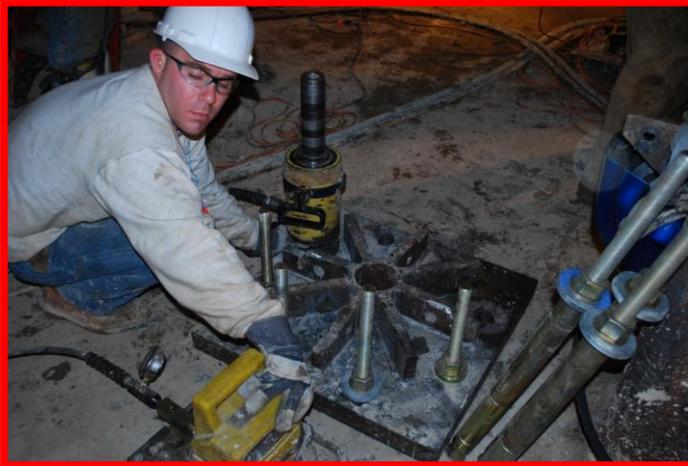
RUSTON FURNANCE - ST. GOBIAN CONTAINERS

Subsurface Conditions: Smith Engineering, Inc., was contacted to investigate the situation. As part of their investigation, multiple soil borings were taken around the site. Moisture accumulated in all borings and retrieved samples revealed water temperature of more than 100 degrees. Furthermore, the upper 10' of the soil mass was found to be saturated. As large volumes of water were utilized in the manufacturing

process, it was determined that leakage of below-grade drainage systems had allowed water infiltration into the soil mass reducing the soil's capacity, thus prompting settlement of the mat foundation.

Design Details: Due to the lack of access below the furnace and low overhead clearance, repair methods were very limited. This was compounded by the massive loads present to be re-supported. Bryan Smith, P.E., called upon Power Lift for repair recommendations. After considering the situation, driven steel piles were the selected repair option. 7" diameter .408 wall steel piles were advanced 30' below grade and founded in the shale formation. Specially designed anchorage assemblies were

manufactured and installed by Power Lift to transmit the load of the mat and furnace onto the piles. The piles were installed in sections 8' in length and connected with full penetration welds. The piles were jacked to an ultimate capacity of 320 kips. After the piles were installed to the proper depth and capacity, the mat elevation was adjusted and secured to the anchorage assembly via welding the piles to the anchor plates. The site was fully restored and returned to operation while the plant was shut down between Christmas and New Year, with construction taking only 7 days to complete.

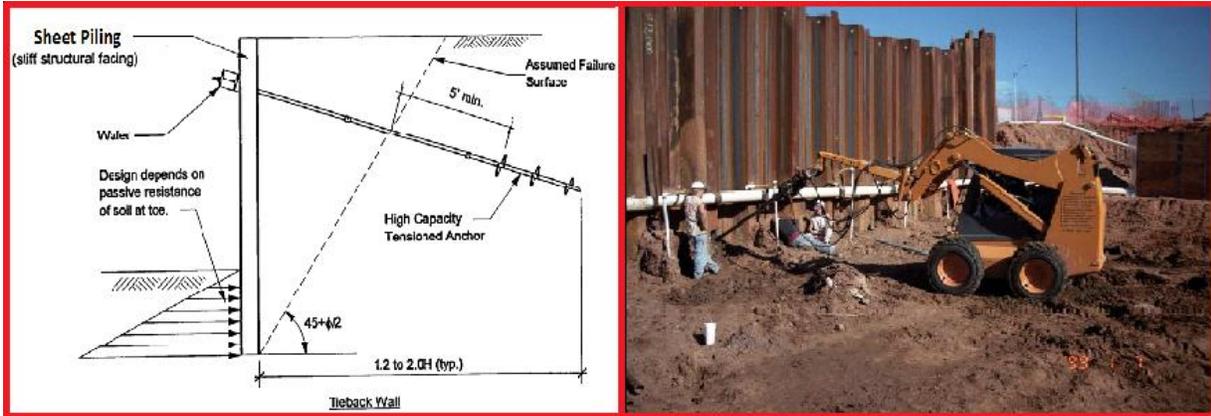
Per the EOR design the Piles were installed at the required angle as seen in (lower right) photo. As well, the design required that 33% of the Piles be proof loaded to the Ultimate Design Capacity before being locked off at the working load.

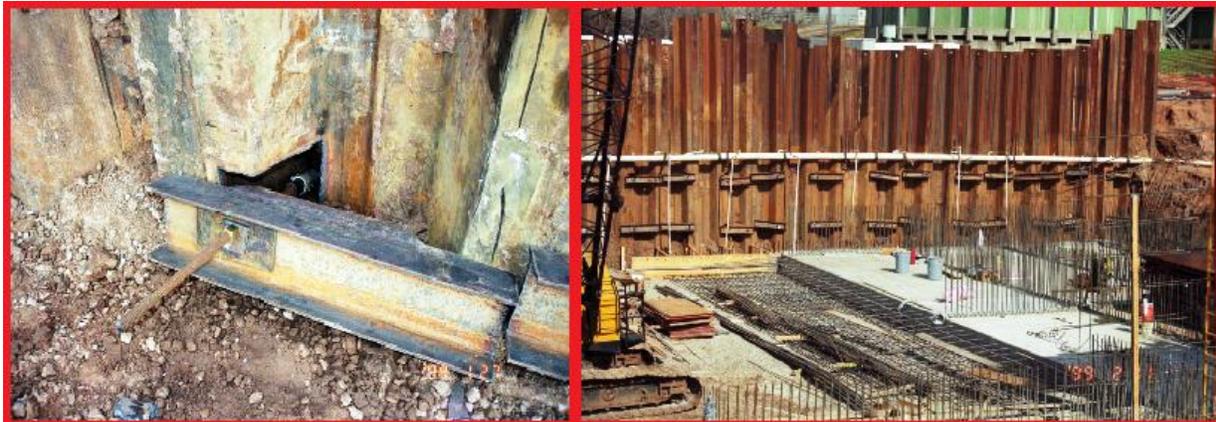
Each helical tieback anchor was driven to a desired installation torque. The sketch (upper left) shows the excavation and the proper angle specified to install the helical anchors. Once the helical anchors were installed a steel I-beam whaler was attached and proof loading was performed to confirm capacity.

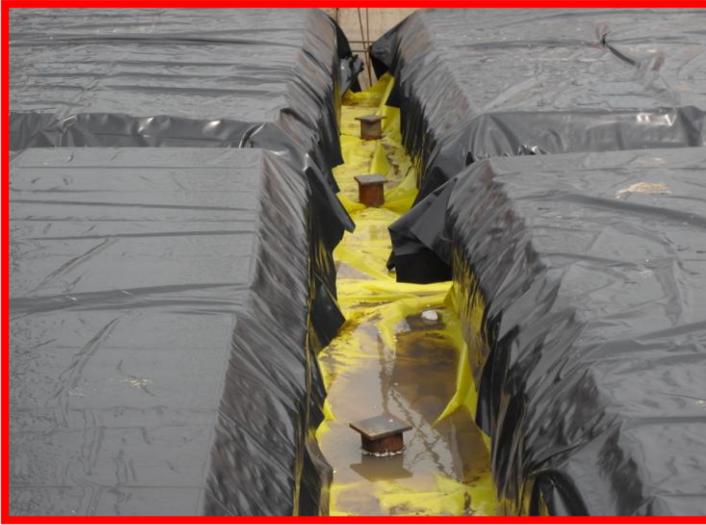
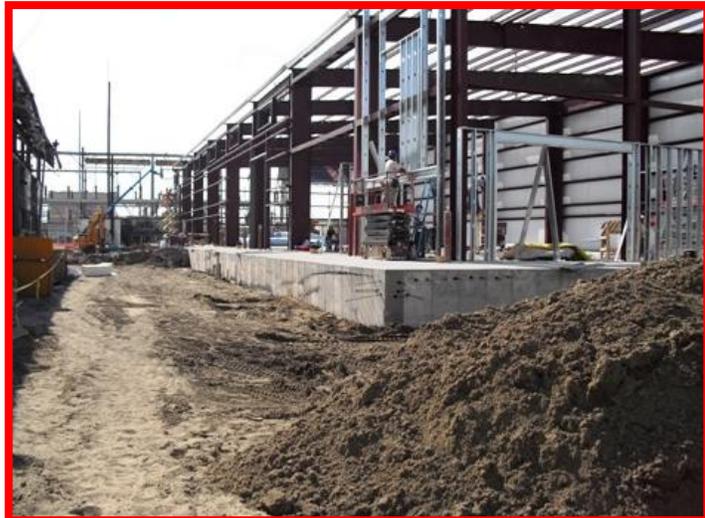
Solution: Power Lift manufactured and installed (470) 3-1/2" O.D. piles with 8", 10", 12", and 14" diameter, 3/8" thick flights. To increase the speed of installation, Power Lift manufactured the majority of the piles in 30' sections so as to reduce the number of couplings required. However, much of the site was congested with overhead power lines. In those areas, 15' pile segments were installed to insure Power Lift personnel's safety. The Power Lift

The contractor provided flat pad sites for the warehouse buildings. A surveying firm established pile locations in the field and set installation stakes at each pile location. The layout was tied to a grid coordinate system which was downloaded to Power Lift's digital torque monitoring equipment. This allowed Power Lift to provide a digital installation log for every pile

installed verifying installation torque and depth. Once pile installation was complete, the piles were cut off at the appropriate grade and pile caps were installed.

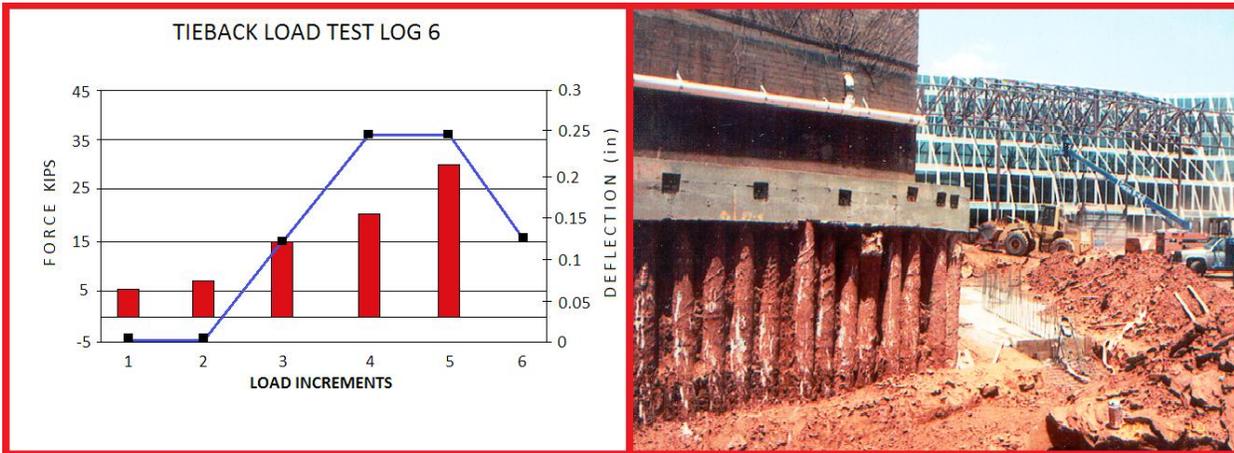
VERIFIED RESULTS!

Each Helical Tieback Anchor was load test to verify the working capacity. The graph (upper left) shows actual test results from load test log on June 6 1998.
